**Ground Penetrating Radar to
Assess Slope and Irregularities in the Base of
Racetracks**

Report on Results of Testing

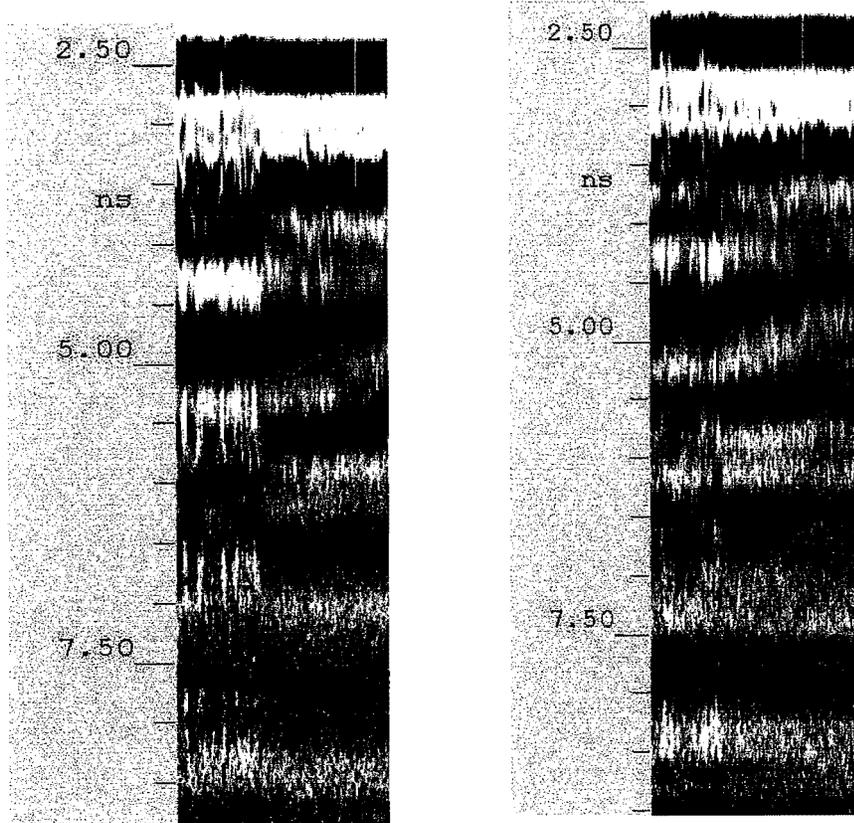
Figure 2: Images of compaction of soil. Compaction in these images is caused by tire tracks of Ford Expedition rolling cross the track to take data from rail.

Given the complexity of working on a operational racetrack, it was not possible to use hoof prints to test the radar because of the large number of prints that almost immediately cover a track after the morning renovation. It was hoped that the ground penetrating radar would be able to identify hoof prints on the track. However initial ground penetrating radar results made it clear that the compaction pattern from multiple passes of so many horses was too complex for isolating hoof prints. An alternative, more controllable method was used to create an understandable compaction pattern. A completely prepared track exists in many locations when racing is not being conducted. The track is fully prepared for the next day of training at the end of the work session. In the morning before training the track is watered and harrowed prior to exercising horses. It is not advisable to use the biomechanical hoof at this time since it can cause a hard place in the track because of the high loads applied. Multiple hits from the biomechanical hoof should be followed by cutting of the track because of deep compaction. Otherwise a hard spot on the track exists which is not removed with the normal roller harrow but requires use of the cutting harrow. The lower loads associated with tire tracks from vehicles are however regularly placed on the racing line close to the rail. Thus it is possible to see if this lower level of compaction produced by tire tracks is evident in the ground penetrating radar image. Figure 2 shows two of the places where the test truck drove across a fully prepared surface at Fairplex Park. The left image is taken closer to the rail where the two tire compaction areas are close to each other due to the truck turning. In the right image which is further from the rail it is possible to see the separate tire impressions in the soil.

It is clearly evident that it is possible to detect compaction in track surfaces even when it is caused by the lower pressure of a light truck passing across the track. Compaction from either a water truck (the highest compaction from any equipment that is used on the track) or galloping horse (either a biological or robotic hoof print) would thus be expected to be very evident. Future work would be to use this new tool to compare track materials, maintenance methods as well as some of the new synthetic track surfaces to develop methods and materials that will reduce sensitivity to compaction and thus reduce spatial variability of track hardness and shear strength.

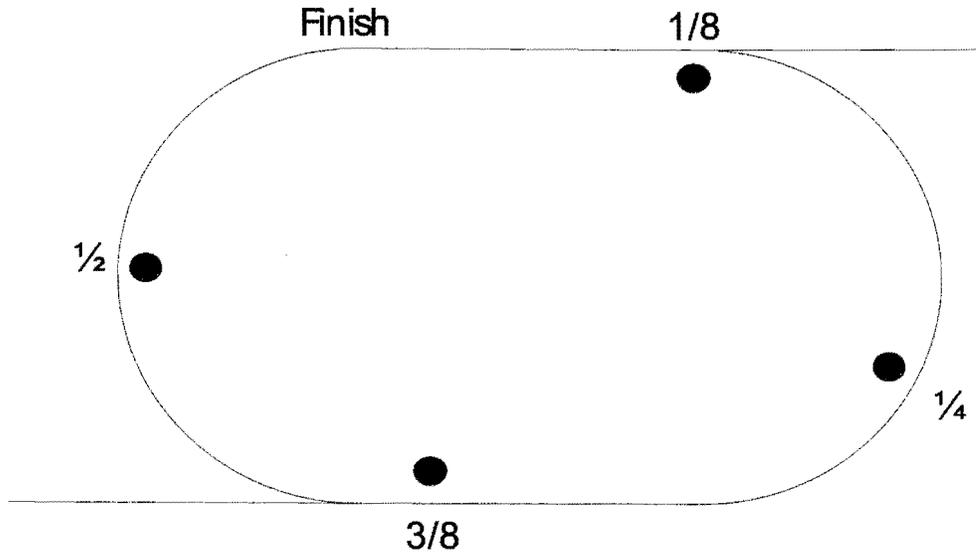
Table 1: Summary of data taken in August 2004 from Fairplex racetrack in Pomona California.

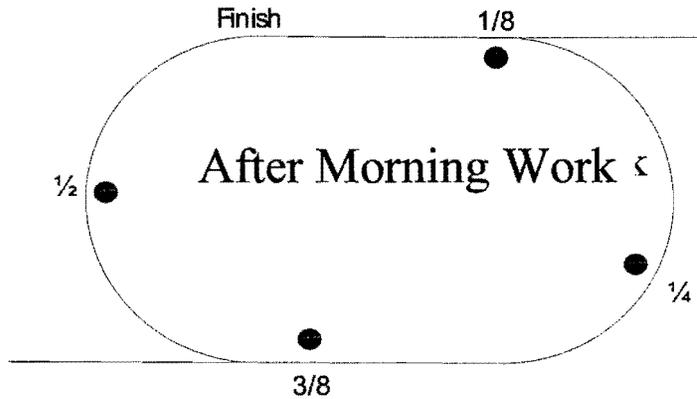
Table 2: Data taken August 11, 2004 at Fairplex racetrack in Pomona California. Detail data for the day shows large variation in peak loads at the 1/4 pole.

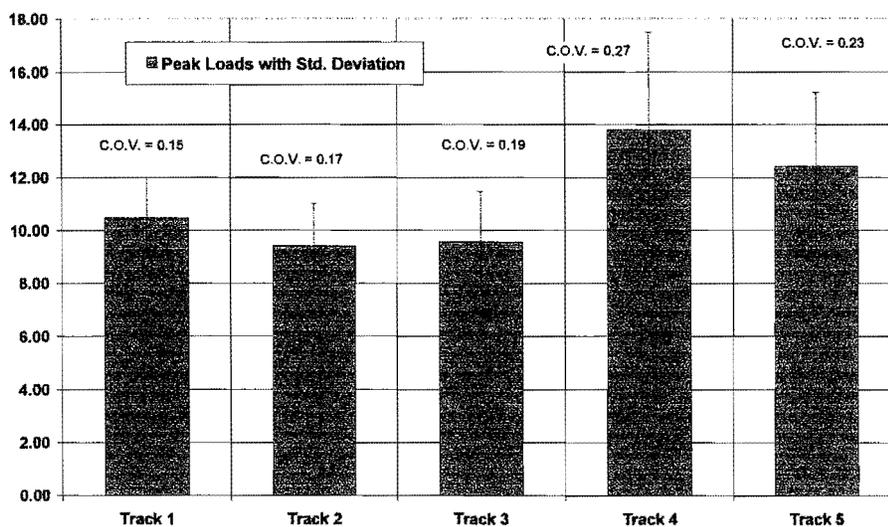
Peak Load -- Track Comparison

Figure 5: Comparison of peak loads measured at five different tracks along with variability.

Over the last two years a study was undertaken to develop a tool that will produce the track surface impact characteristics at the same loads and loading rates produced by a horse at a gallop. The first phase was the development of the machine along with pilot data which was funded by AQHA Racing. The second phase was a comparison test of a number of tracks in California. The second phase was performed over the course of the summer of 2004, and supported by the Thoroughbred Owners of California, California Thoroughbred Trainers, the California Association of Racing Fairs and a number of racetracks including Santa Anita, Hollywood Park and Del Mar. This second phase has significantly altered the understanding of track mechanics and characteristics of interest. The test system differs from previous studies in that the loads applied to the track and the rate at which they are applied are the same as those encountered during the impact of a hoof on the ground. This is important since previous work has typically only characterized the performance of the cushion, or top layer of the track, at a rate that was much slower than the hoof ground impact. At most California tracks a second layer, or pad, is used to reduce the peak loads and ensure that a consistent tractive surface is available for the horse. The consistency of the base, which is always critical, becomes even more important if a pad is not used on the track. The system developed measures the dynamic performance of both the pad and the cushion. Strength and stiffness of the cushion and the pad have been measured, providing quantitative information that can be used to compare track surfaces. A summary of results from tracks tested in the summer of 2004 are shown in Figures 5 and 6.

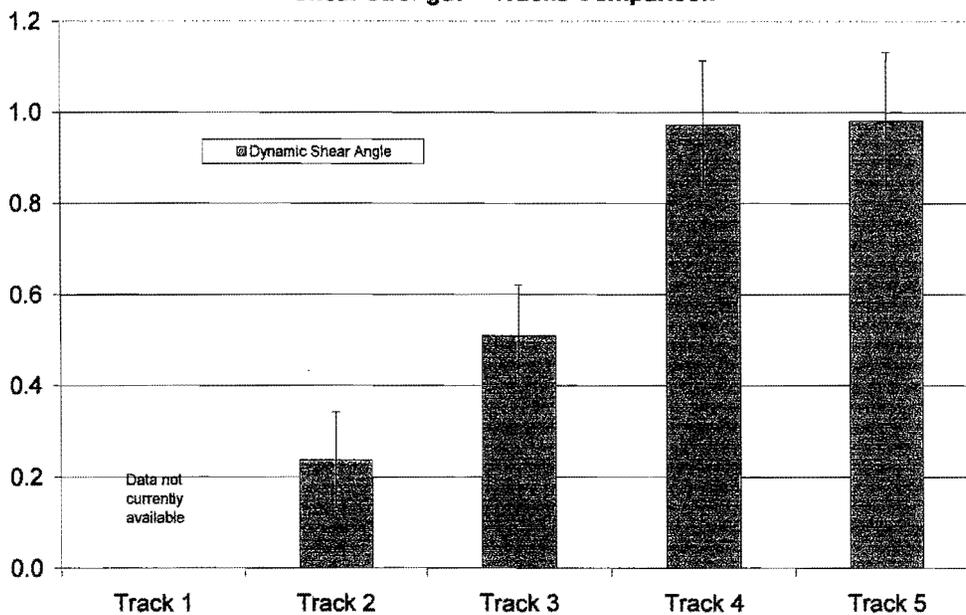
Shear Strength -- Tracks Comparison

Figure 6: Comparison of dynamic acceleration ratio measured on four of the same tracks shown in Figure 4 for peak load.
